# CLOSE COUPLE TOILET

Signature Hygiene Rim CCBTW - Back Inlet with  
CrystaSleek Seat AS01022

## Installation Manual

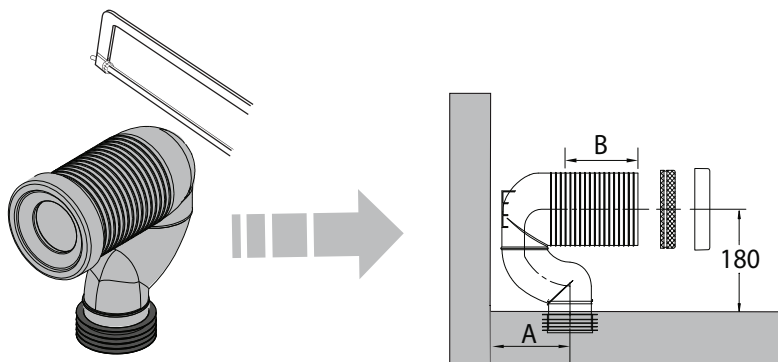
5a

| ROUGHING - IN<br>(A) | CONNECTOR<br>CUTOUT (B) |
| 140-150 mm. | 50 mm. |
| 151-159 mm. | 60 mm. |

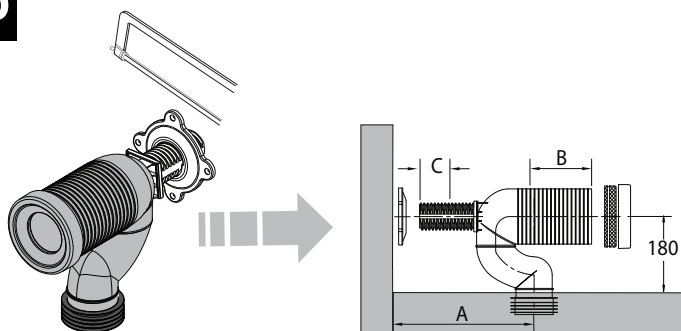
5b

| ROUGHING - IN<br>(A) | CONNECTOR<br>CUTOUT (B) | ROUGHING-IN<br>(A) | CONNECTOR<br>CUTOUT (B) |
| 160-170 mm. | 70 mm. | 211-220 mm. | 120 mm. |
| 171-180 mm. | 80 mm. | 221-230 mm. | 130 mm. |
| 181-190 mm. | 90 mm. | 231-250 mm. | 150 mm. |
| 191-200 mm. | 100 mm. | | |
| 201-210 mm. | 110 mm. | | C=116 - (A-160) |

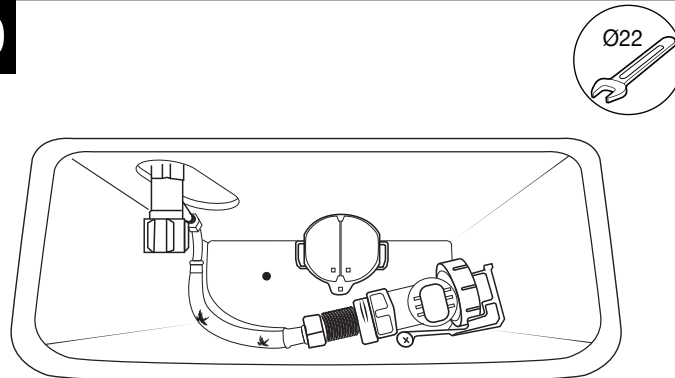
**10**

The flexible hose in this cistern must not be submerged in water at any time.
