# CLOSE COUPLE TOILET

Signature Hygiene Rim CCBTW - Back Inlet with Std  
Seat AS01024

## Installation Manual

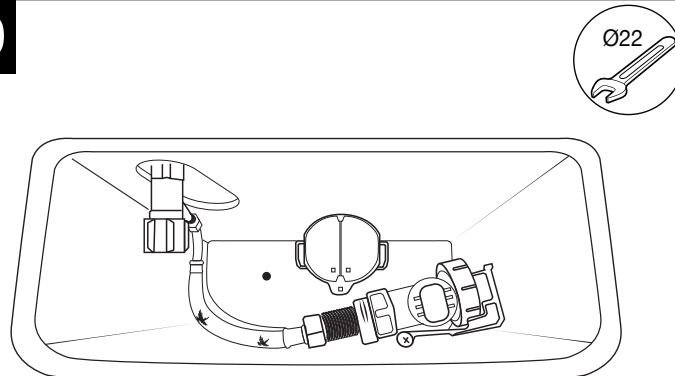
10

The flexible hose in this cistern must not be submerged in water at any time.
