# CLOSE COUPLE TOILET

Signature Hygiene Rim CCBTW - Back Inlet with  
SpaLet E-Bidet Seat AS01030

## Installation Manual

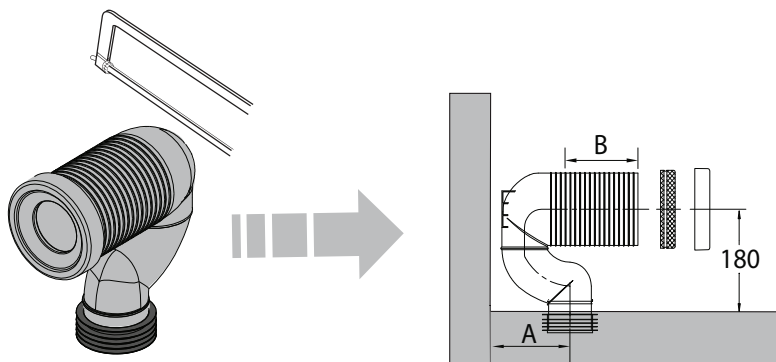
5a

| ROUGHING - IN<br>(A) | CONNECTOR<br>CUTOUT (B) |
| 140-150 mm. | 50 mm. |
| 151-159 mm. | 60 mm. |

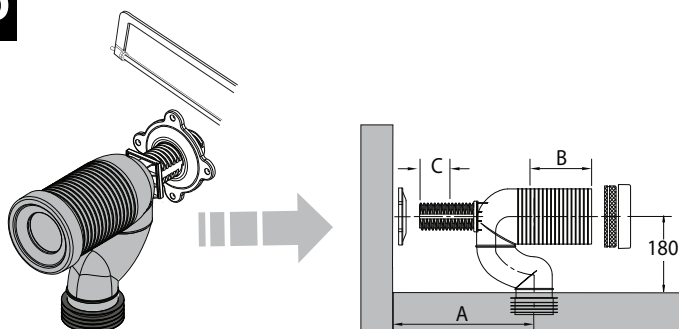
5b

| ROUGHING - IN<br>(A) | CONNECTOR<br>CUTOUT (B) | ROUGHING-IN<br>(A) | CONNECTOR<br>CUTOUT (B) |
| 160-170 mm. | 70 mm. | 211-220 mm. | 120 mm. |
| 171-180 mm. | 80 mm. | 221-230 mm. | 130 mm. |
| 181-190 mm. | 90 mm. | 231-250 mm. | 150 mm. |
| 191-200 mm. | 100 mm. | | |
| 201-210 mm. | 110 mm. | | C=116 - (A-160) |

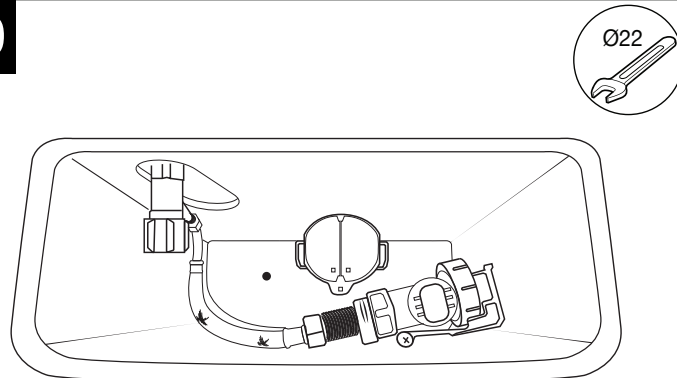
**10**

The flexible hose in this cistern must not be submerged in water at any time.
